## Infrared Thermography as a Reliability Tool

## ◆ 9.2 CASES

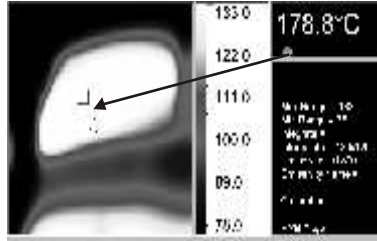
### 9.2.1 PRODUCTIVITY AND QUALITY DEPENDS ON REFRACTORY HEALTH

This thermogram (heat picture) shows a portion of refractory wall. Since it is almost impossible to stop furnaces and kilns to measure refractory thickness thermal imaging offers the only viable technique to do so. By measuring the temperature on the shell it is possible to estimate the amount of wear that has taken place inside. It is also possible to estimate the amount of loss of radiant heat from an area. If the loss is too much then cost goes up in terms of extra fuel or energy that is needed to achieve process parameters. Moreover, quality of the product becomes

inconsistent. In this particular case, the loss of radiant heat was almost 4 times the normal and the quality was inconsistent. It meant that for every unit of energy added to the system only 25% could be utilized for the process the balance 75% was sheer wastage.

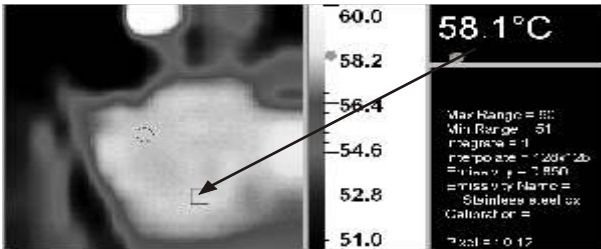
### 9.2.2 FINDING THE ROOT IMPERFECTION OF ANTI-FRICTION BEARING

This thermogram shows the end view of an ID fan Non-drive end bearing in a Plummer block. There was noise from the bearing but vibration analysis was unable to detect the cause.

The thermogram clearly shows that the rollers were rubbing against the cages. The only reason could be that the bearing was skewed in its housing. It was found that the housing was 14 years old. The last bearing also gave similar symptoms and failed within 3 months. Had it not been for thermography this root imperfection would have remained undetected and the bearings would have kept on failing one after the other.

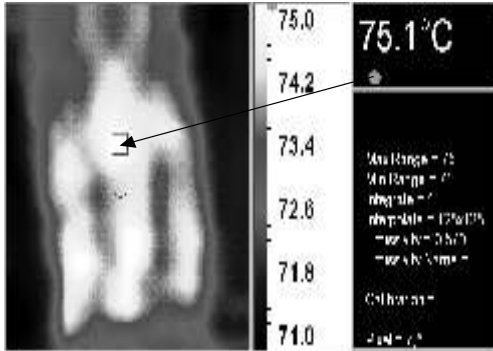
### 9.2.3 FINDING AN ELECTRICAL UNBALANCED LOAD

This thermogram shows the thermogram of an electrical connection. Though the temperature may be said to be just outside the normal range

an unusual phenomenon was observed. In most panels the Y phase was

found hot. This led to the conclusion that the electrical load was unbalanced. Had the situation continued it would have led to a series of failures of electrical connections thus disrupting production? It may be noted that other than infrared thermography (always non-contact) it would not have been possible to find the problem in electrical circuits in any other way. Moreover, this method is the only safe method to observe abnormalities in electrical installations.

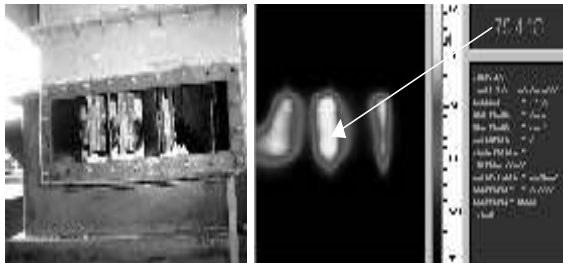
#### 9.2.4 FINDING THE CONDITION OF TRANSFORMER

This thermogram shows all the contacts of the transformer as shown to have higher temperature, especially the Y phase. The analysis showed that the problem is not connected to load. It is a local transformer problem. The contacts are to be cleaned and re-tightened. The gas in oil is also high. The transformer oil is to be checked for moisture content and dielectric strength. Condition the oil or change oil as per findings.

If the oil were not taken care of the contacts would again develop higher temperature. So temperature pattern or distribution reveals a lot of

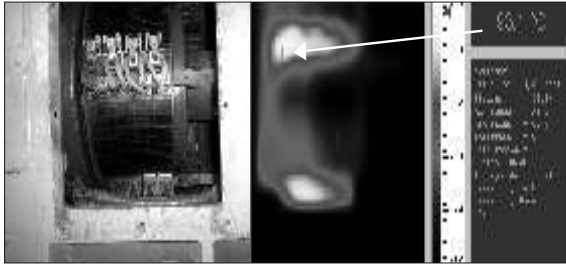
### 9.2.5 FINDING OUT THE SUITABILITY OF COMMUTATOR BRUSH MATERIAL

This thermogram reveals two distinct temperature patterns for the two different types of brush materials used in this motor. There would be no other method to understand the comparative performance of two materials other than the time taken for each brush material to fail. With thermography one would easily find out which material is inferior to the other. The material on the upper holder is inferior to the material on the lower holder.

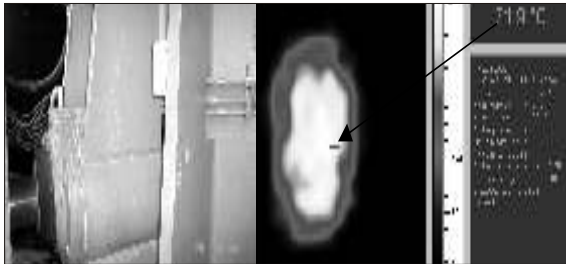
### 9.2.6 IMPROVING THE LIFE OF BEARING AND GEARS IN A HIGHLY LOADED GEARBOX

This thermogram was taken for a highly loaded gearbox. The bearing, gearbox in general was found running hot and in a distress condition. The root cause of the heat generated was inadequate lubrication. At the temperature of around 72 degree Centigrade, the oil would get oxidized and lose its effectiveness in lubricating the gears. As a result, the bearing would not run to full life and the gears may also develop fatigue over time. It may manifest as pitting or breakage. Hence it was recommended to control the oil temperature. As a short term measure the existing heat exchanger may be cleaned. As an improvement measure, the efficiency

and effectiveness of the heat exchanger may be done by several means. Such analysis of root design imperfection would not have been possible with any other techniques but infrared thermal imaging.

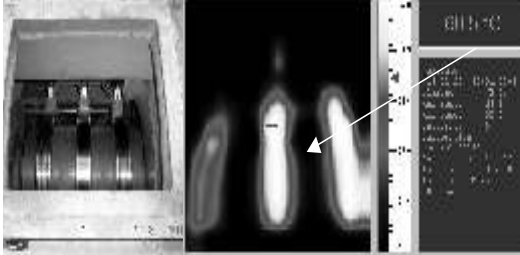
### 9.2.7 FINDING THE CONDITION OF SLIP RING

This thermogram was taken to find out the condition of the slip rings. It was found that the R phase (the extreme left hand side contact in the thermogram) slip ring interface shows less temperature than optimum temperature level. It meant that the spring has lost tension. Hence this contact/spring may be replaced at the next opportunity. Had it continued in this manner there would have been a possibility of an early failure. Such failures could be very easily avoided by the use of thermal imaging technique. It is more useful since the technique could be applied online.

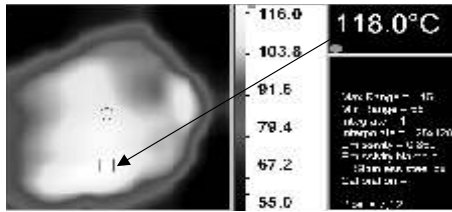
### 9.2.8 FINDING THE INSULATION CONDITION OF MOTOR

This thermogram shows heat generation at the bottom of an induction motor. And the temperature is quite high for 'B' class insulation. Obviously this motor would fail. However, the thermogram shows a weak insulation at that area. Matters could probably be improved by revarnishing the insulation. It would not have been possible to detect this abnormality so quickly by other means while the motor was running. Thanks to thermal imaging that it also possible to check motors in operation.
